AIAA Space 2011 Conference

NASA/MOD Operations Impacts from Shuttle Program

Authors: Michael Fitzpatrick, Gregory Mattes, Michael Grabois, Holly Griffith

## II. STS-27 Post-Landing Cooling Anomaly

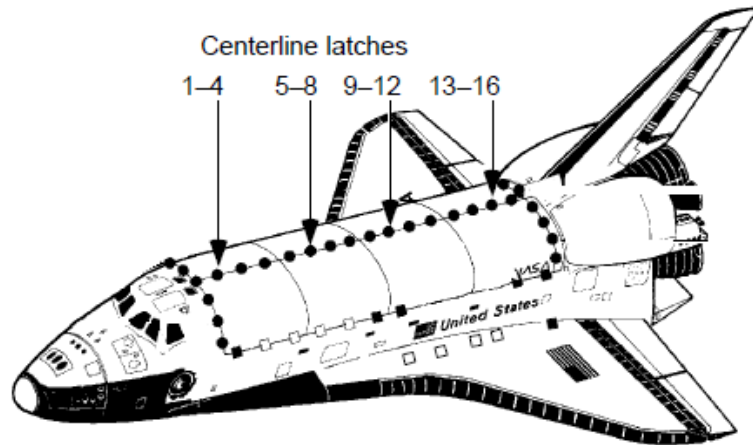
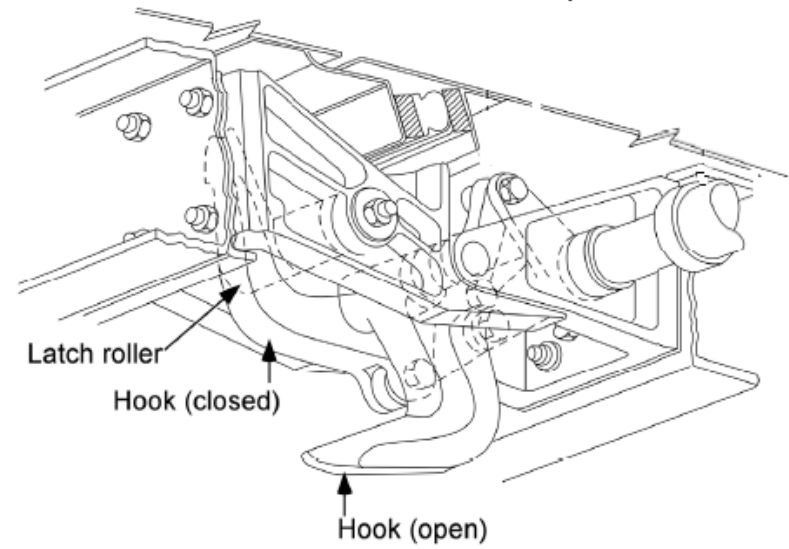
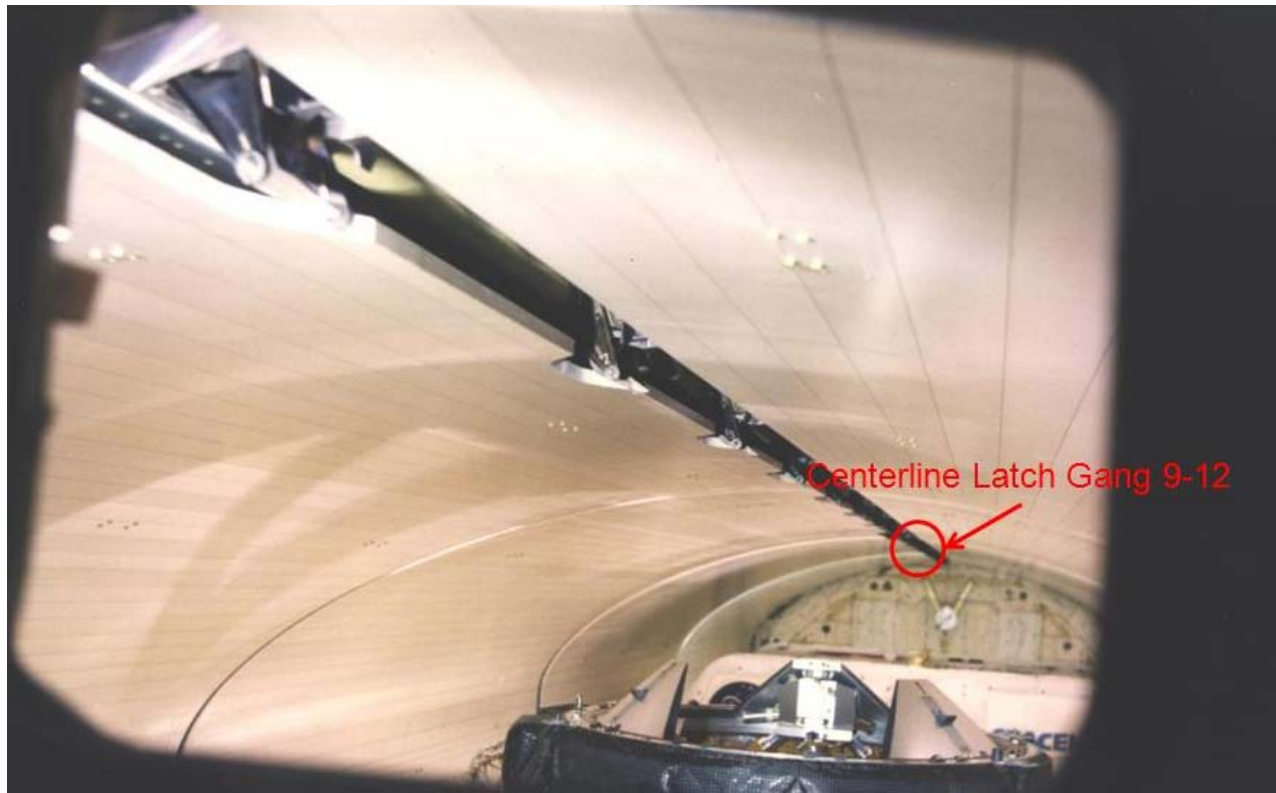
Centerline Latch Closeup

- Crew closed PLBDs to prepare for Entry
  - Weather was poor, so team waived off for the day
- During PLBD opened (performed to regain vehicle cooling for orbit ops) centerline latch gang 9-12 appeared to never open
  - Two microswitches indicated latch did not reach end of travel.
- Control team was in a time critical situation
  - Could the PLBDs be opened to regain cooling?
  - Did the Shuttle require an emergency deorbit?

- PLBD centerline latch gang 9-12
  - Came off two closed microswitches
  - Did not receive two open microswitches
  - Alternating current traces were inconclusive
    - Latch gang 5-8 and 9-12 were driven simultaneously
      - Latch gang 5-8 reached end of travel at the expected time
- PLBDs cannot be opened with one centerline latch gang closed
- Potentially unsafe to open PLBDs with centerline latch gang at undetermined position
- NEED TO DETERMINE THE LATCH POSITION

- Team was unable to determine latch position with microswitch data
  - Latch may have been fully open with two microswitch failures
  - Latch may have been at a position mid travel
- AC trace data was inconclusive
  - Current magnitude dropped to approximately 50% magnitude when latch gang 5-8 reached end of travel
    - Latch gang slip clutch may have been slipping for entire drive time
    - Latch may have starting slipping half way through drive
    - Latch may have been driving the entire time

- Microswitch failures were most likely due to the radiator cold soak during deorbit preparation procedures
  - Microswitch failures were more common during deorbit prep PLBD opened versus PLBD opening in the post insertion timeframe
- PLBD opening procedures were changed to separate the drive of the first two latch gangs
  - Allowed for the AC traces to be interpreted
- PLBD opening was moved to beginning of the deorbit prep backout procedure to allow for more troubleshooting time should another failure occur

- Team needed another way to determine the latch position
  - Looked at back windows
  - Ingressed the SPACEHAB module to look out the viewport
    - The 9-12 latch gang was directly above viewport
  - Used preplanned visual verification procedures and aids on board to verify position
- Using multiple visual cues, the crew was able to determine the latch gang was in the fully open position
  - Problem was a dual microswitch failure
  - Crew was able to open the PLBDs and regain radiative vehicle cooling
